Technical Note N-886

ROTECTION OF FLOATING PONTOONS FROM CORROSION -- PART I.

INSTALLATION AND INITIAL PERFORMANCE OF TEST FLOATS

17 April 1967

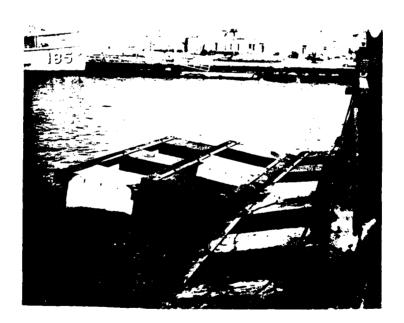
Figure 6. Test pontoon floats in storage available for use by the fleet.

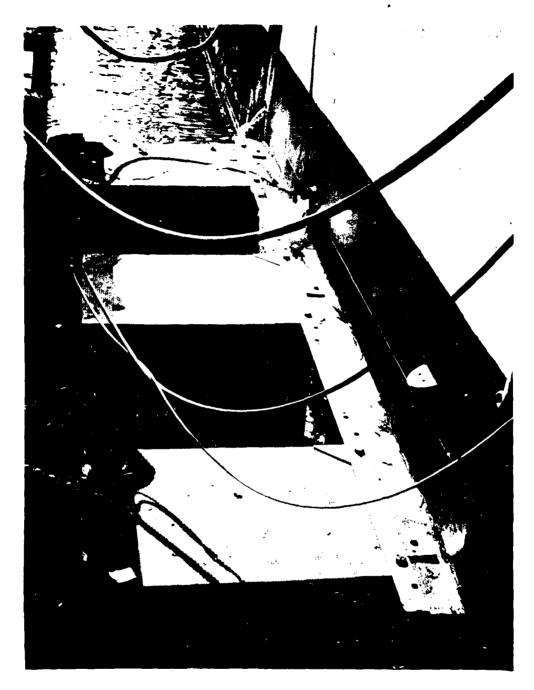
The three test camel floats were placed in the storage area (Figure 6) along with other such floats available for fleet use. These floats are being used extensively by the fleet (Figure 7) receiving the type of service for which they were designed. In such use, they accumulate a film of oil at the water line from floating oil in the harbor and an accumulation of miscellaneous debris dumped over the side of the moored vessels (see Figure 7). Nevertheless, the three coating systems have provided excellent service with no apparent damage after six months of service to the fleet. The tops of the pontoons were cleaned with sea water and a stiff bristle brush before examining the coating.

Figure 7. Test pontoon float serving the fleet.
